Volume 20 Issue 4

October 2026

# PUKEMIRO JUNCTION

The Glen Afton Line

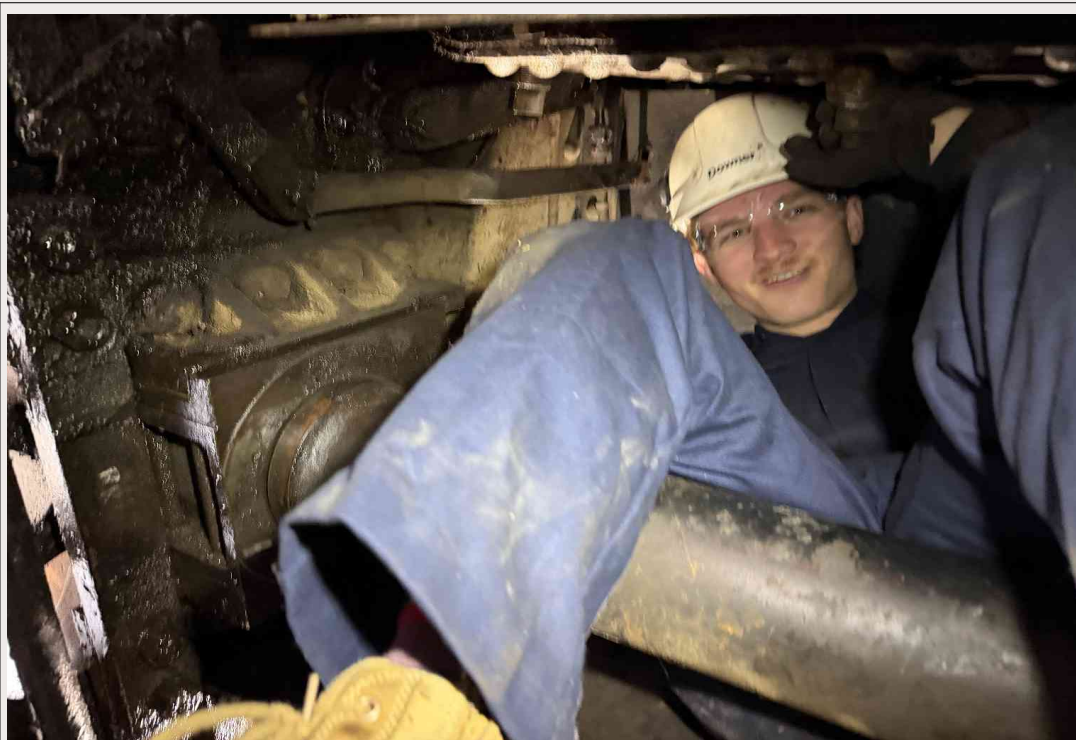
**Above:** Evan W installs Peckett springs in a very confined space (GuyC)

Later in the day on the August & September open days, the Peckett had suspension issues & had to be towed back to the yard. As a result, we have had the 3 springs away getting checked & reset that weren't done earlier in the year.

**Peckett Loco:** This loco has spent the last month or so in the workshop jacked up & sitting on blocks. We had found problems with 3 of the springs, so we had them taken to Archers in Rotorua for repair, overhaul. We now have all springs reset to the same measurements.

To check the springs, they are completely pulled apart & each leaf heated & set. They are then put back together & have a buckle put around all the leaves of each spring. & a pin or bolt goes through them all at the centre. Archers found that the buckles were pretty worn so they were repaired as well. The loco was test run on the day before our October open day & didn't give any problems but wasn't used. A large number of our members have helped with this job.

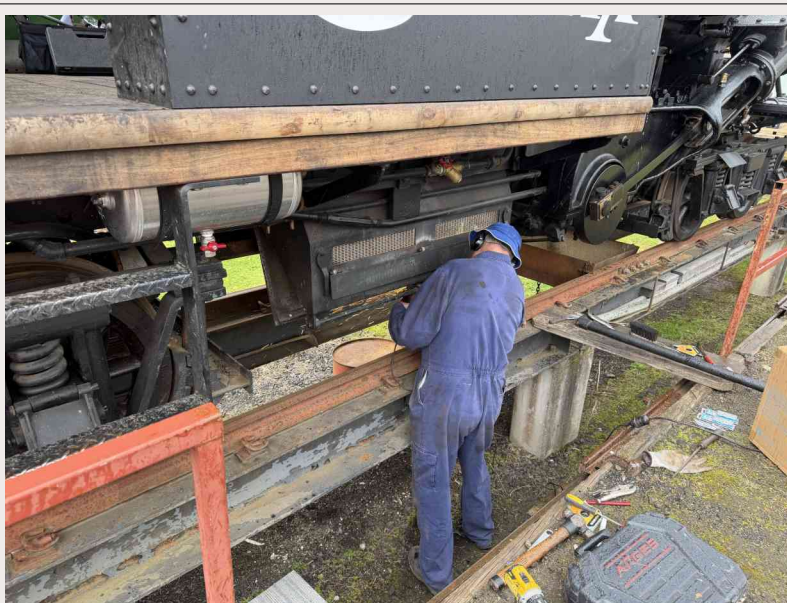
**Right:** Climax ashpan alteration (ChrisM)

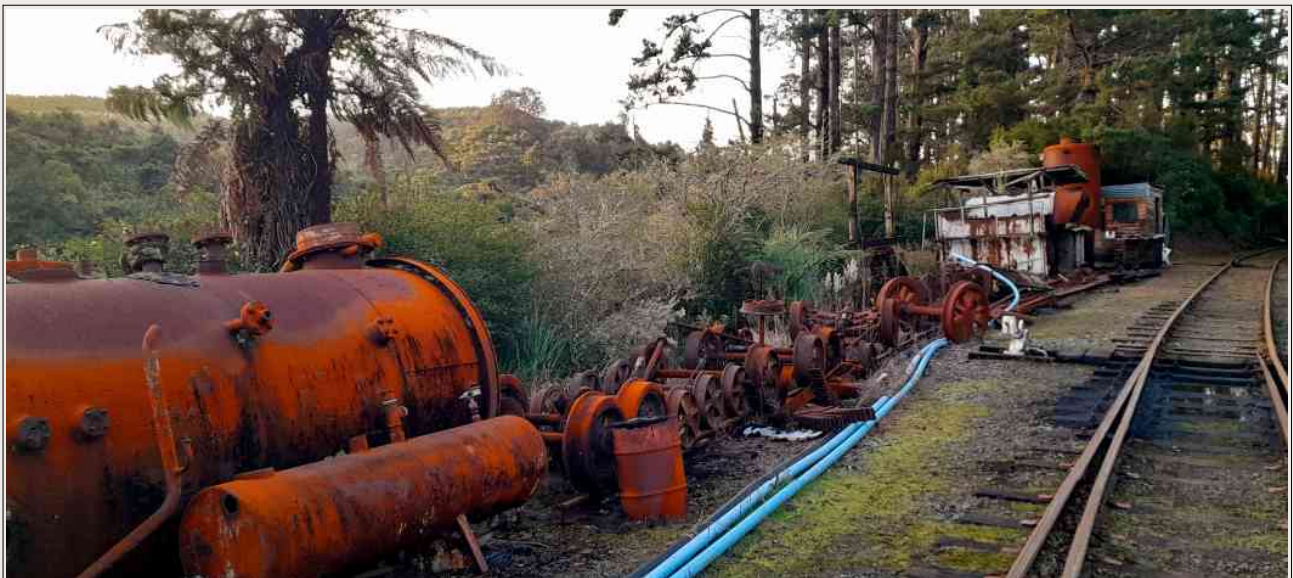
**Above:** Bright algal patina on metal trackside in the lower end of the yard (JS)

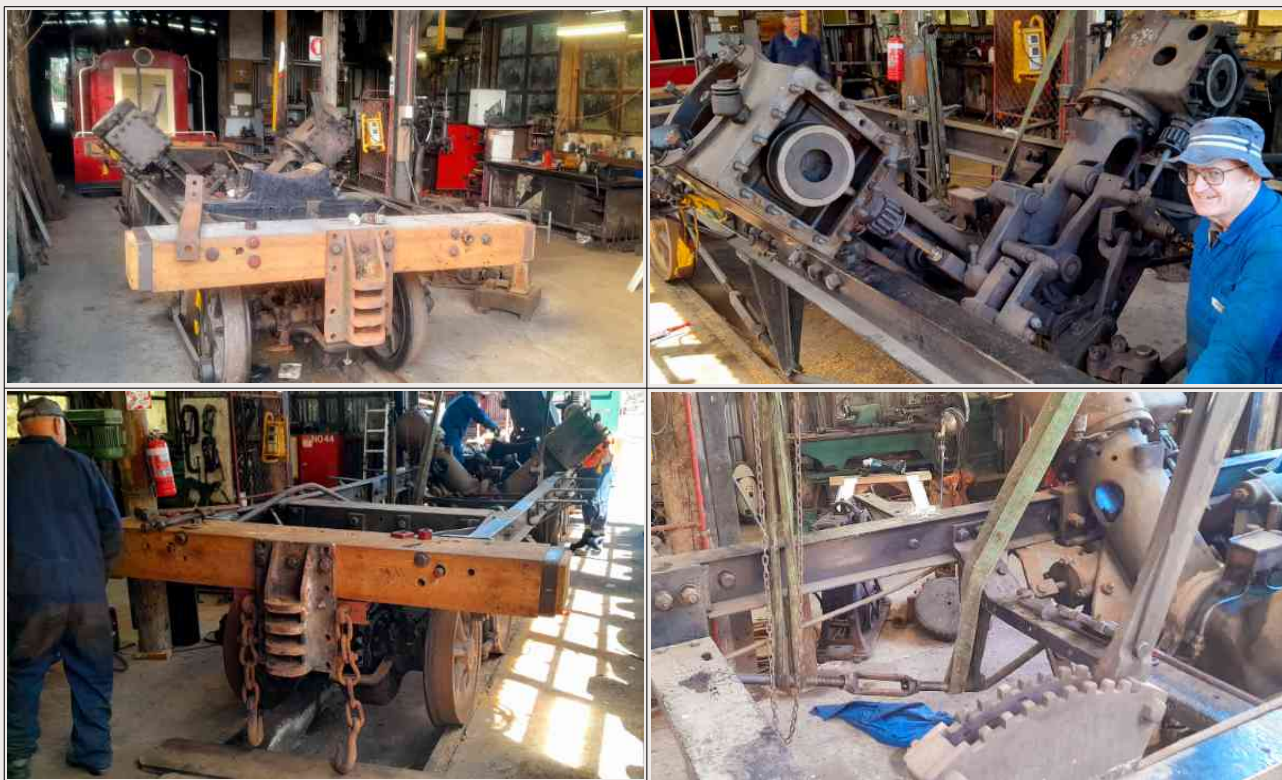
**Above:** A big Heisler work weekend recently – headstocks, cylinders, cab measure, etc. (JS)

**Heisler Loco:** A recent working-bee has fitted the new headstocks onto each end of the loco, thanks to Richard S, Clive D, Fraser R, Alan U, JS, & others.

Chris M has started cleaning & stripping the old sections of the cab sides of this loco, & cleaning the frame work part of the cab that can be reused.

Further working-bees are planned in the very near future. Fraser R is arranging for drawings of the various parts of the steel work needed for the cab in order to get quotes for purchase of steel.

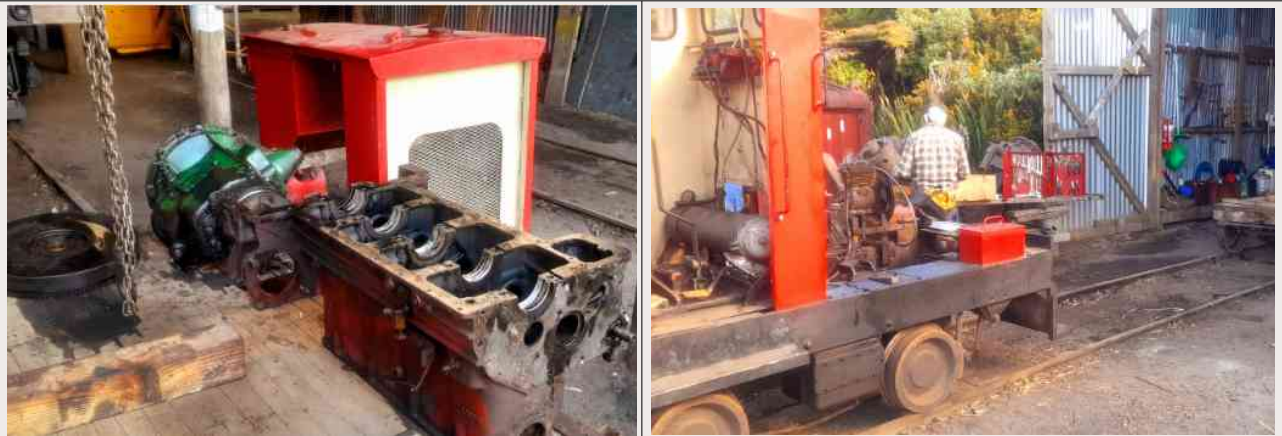
*Above: Planet engine reco work progressing on the same weekend recently (JS)*

The head of the engine was taken to an engine reconditioner in Hamilton so it could be looked at & a quote given to us. We have just heard that the work that needed to be done to complete the head job has been carried out!!

Graeme C has spent a couple of days dismantling the engine & now has one of the cylinder liners out. He has obtained a set of crank shaft bearings.

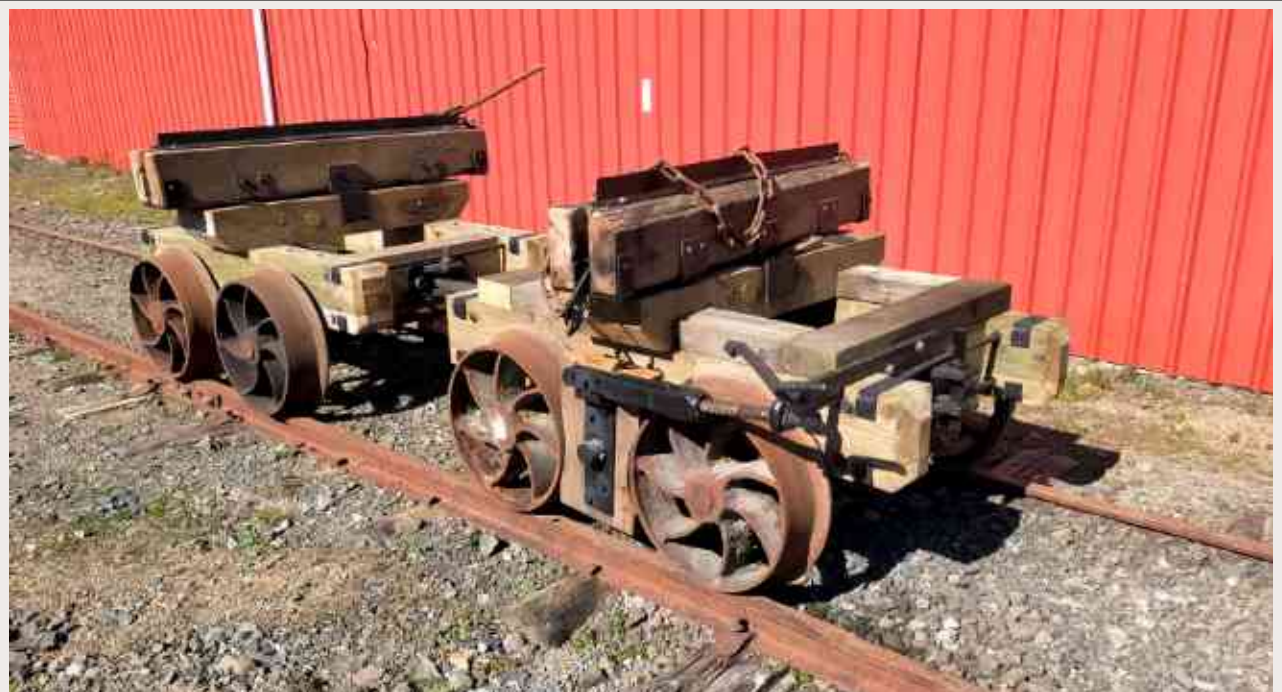
*Above: Completed log bogies, complete with hand-operated brake (Bruce McL)*

**Log bogies:** Bruce McL has now completed the building of these. He has made & fitted a wooden brake block & the operating gear for this. He has now completed the bolsters that fit on top of the bogie itself & that the log sits on & is chained to this bolster. These bolsters swivel as the bogie goes around corners.
